18. SUPPLEMENTARY NOTES		
19. KEY WORDS (Continue on reverse side if necessary and identify by block number) Dams Dam Safety National Dam Safety Program Akers Dam, TN Turners Station, TN Sumner County, TN. Embankments Visual Inspection Structural Analysis

PHASE I INSPECTION REPORT
NATIONAL DAM SAFETY PROGRAM

Name of Dam Akers
County Sumner
Stream Unnamed Trib. of
Little Trammel Creek
Date of Inspection April 15, 1981

Akers Dam, Sumner County, Tennessee

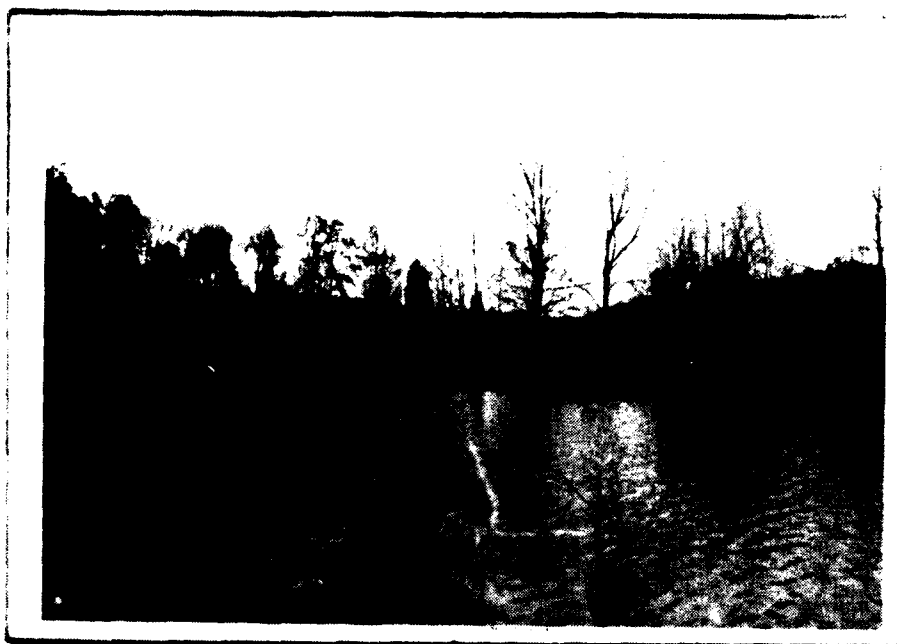
PHOTO NO.5

2.4.2 Service/Emergency Spillway - The service/emergency spillway founded on dolomite bedrock at the left abutment. The earth and rock side slopes vary down the channel between 1.6 to 2.8H:1V on the left side and between 6.1 to 8H:1V on the right side (Figure 5). Large dolomite slabs were placed on the right slope. The crest elevation at the spillway is approximately 814.9' msl. The spillway channel is roughly 150 feet long and runs perpendicular to the axis of the dam (Figures 3 and 7; photo nos. 5 and 6). Outflow from the channel cascades down the side of a natural draw to the old stream channel.

- Photo No. 4 - Downstream face.
- Photo No. 5 - Spillway entrance channel.
- Photo No. 6 - Spillway control section and discharge channel.
- Photo No. 7 - Downstream toe in area of drawdown drain valve.

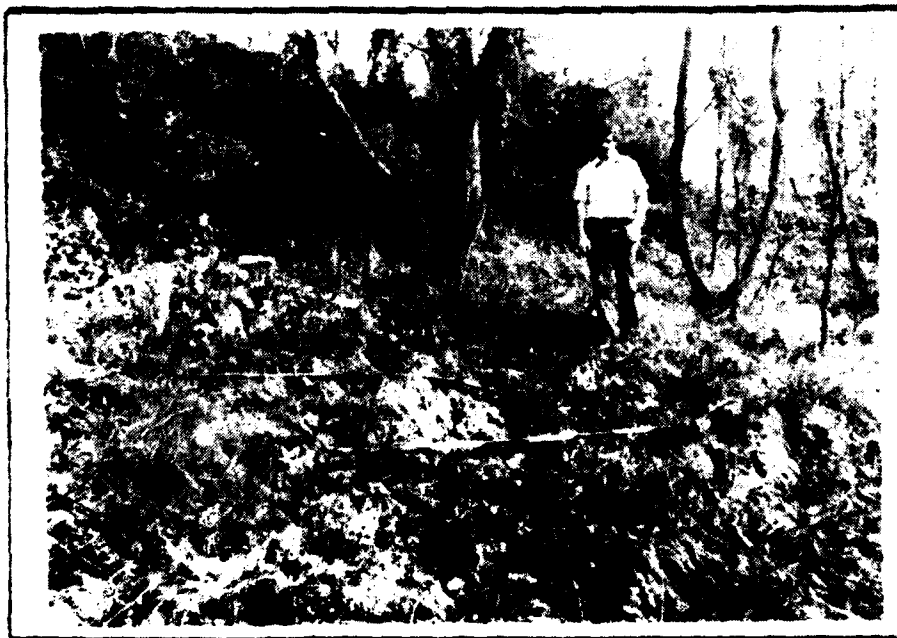
PHOTO NO. 10

- Photo No. 10 - Sloughing in the area of extensive seepage.
- Photo No. 11 - Extensive seepage area from left abutment. Note plush vegetative growth.
- Photo No. 12 - Extensive seepage area from left toe area.
